**Heyford Park
Dorchester Living: Phase 9
Remediation Earthworks Completion Report
For Urban Regen Ltd.
August 2021**

Report Ref: R1742-R23-v2

Report Title: Heyford Park, Dorchester Phase 9
Remediation Earthworks Completion Report

Client: Urban Regen Ltd

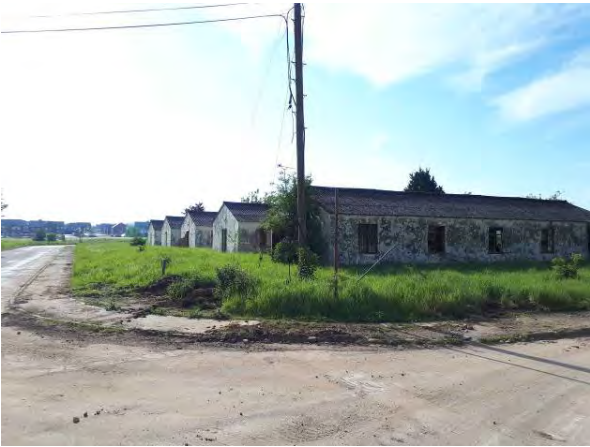
1.

22.05.18 – Eastern view across north of site. Derelict buildings lined across site associated with former school classrooms.

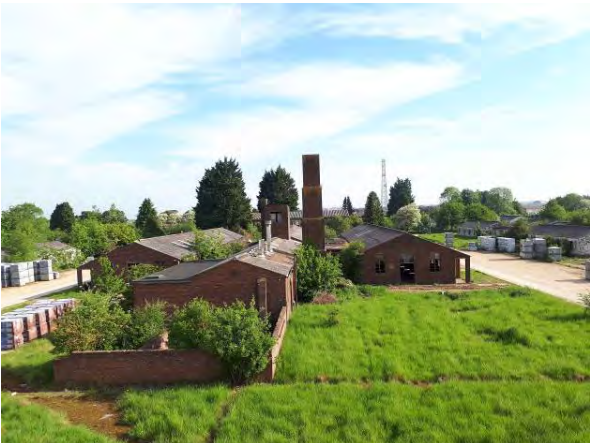
3.

22.05.18 – Former boiler house in the centre of the site (chimney) with USTs

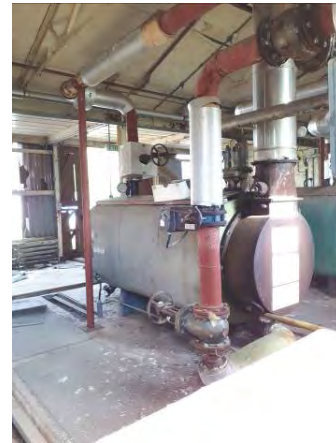
4.

22.05.18 – boilers within boiler house

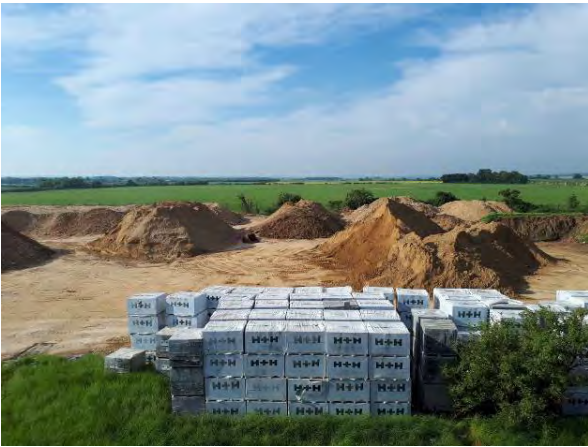
7.

22.05.18 – Temporary stockpile storage area in the south.
Development arisings generated from wider Heyford development

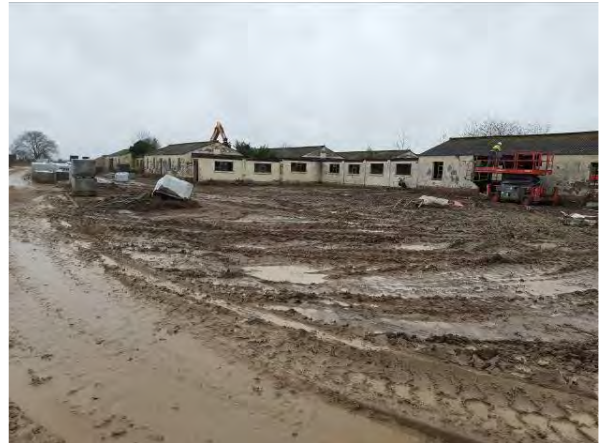
10.

20.01.21 - Asbestos strip in northern buildings

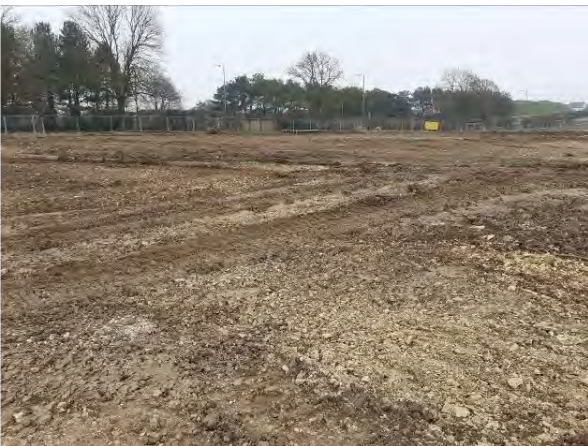
23.

02.03.21 – Formation soils ready for sampling in northeast of site

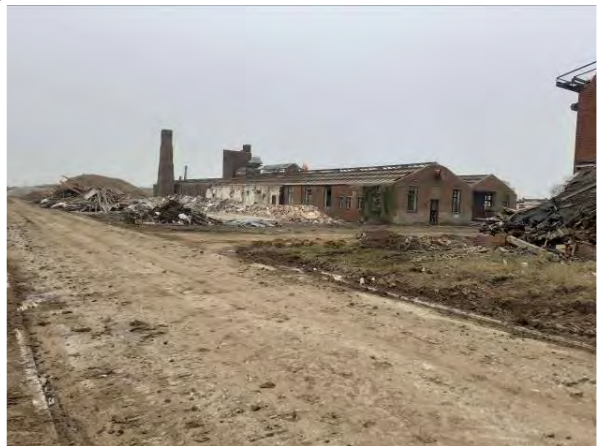
24.

02.03.21 – ACM strip of boiler house complete, internal strip of boilers on-going

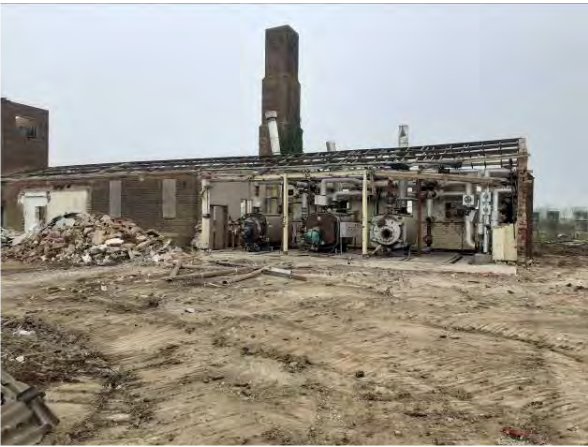
25.

02.03.21 – Boiler house

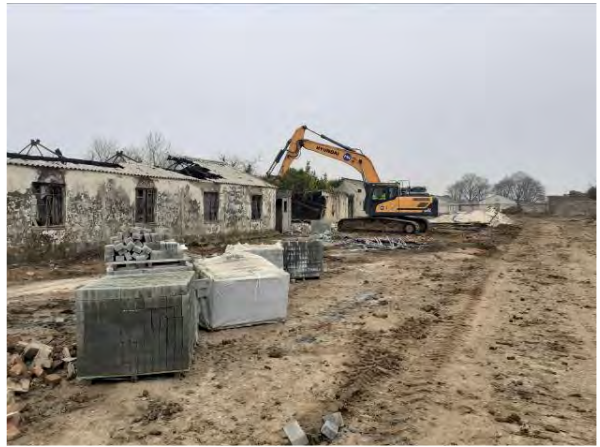
26.

02.03.21 – Demolition of buildings in north/centre of site following ACM strip

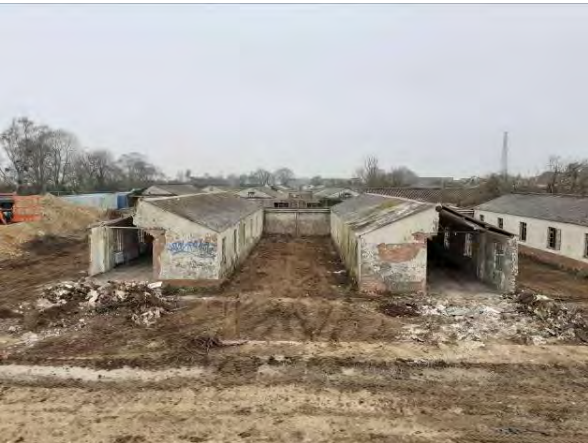
27.

02.03.21 – Northern view of site from southern end. Buildings awaiting ACM strip

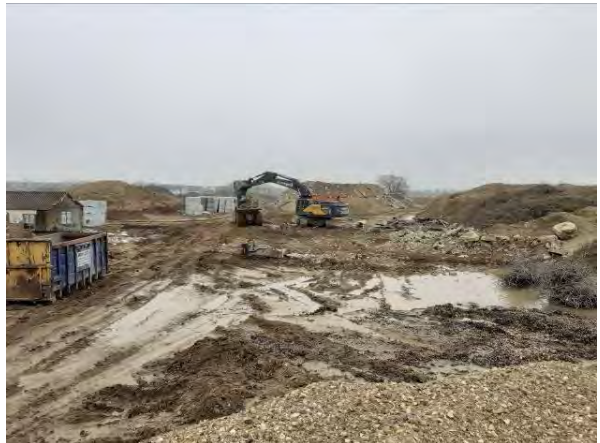
28.

02.03.21 – Recovery of metal waste in to recycling skip in the southeast

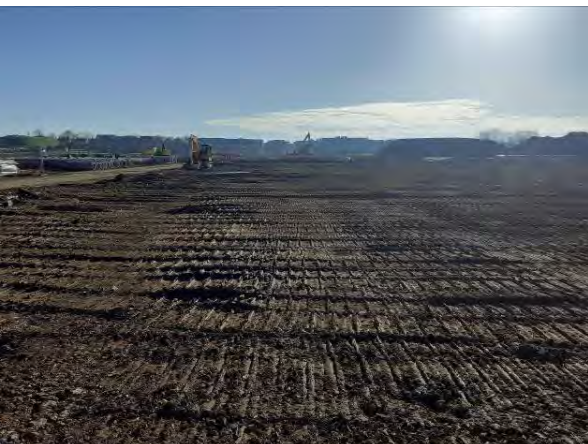
29.

09.03.21 – Eastern view following regrade completion

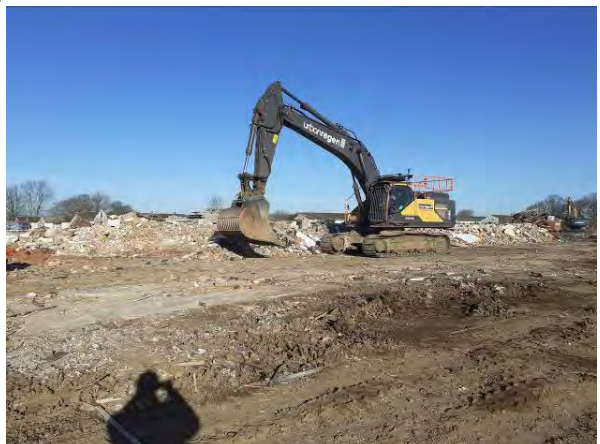
30.

09.03.21 – Breaking out of hardstanding (slab) below demolished building footprint

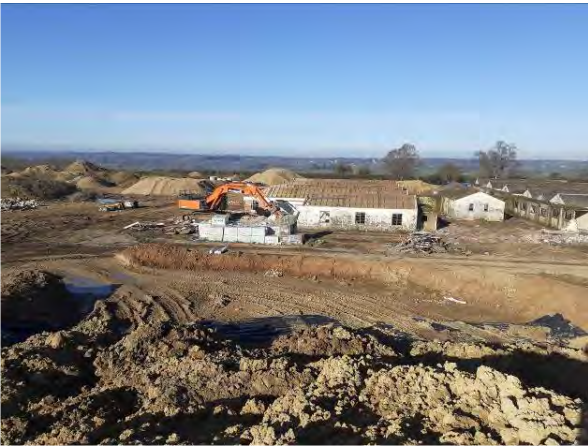
31.

09.03.21 – Western view across the southern half of the site

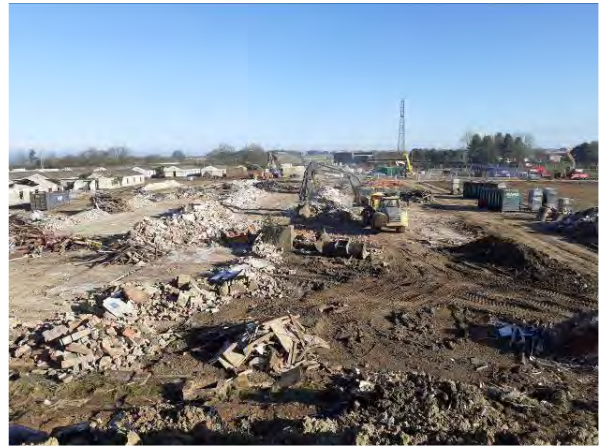
32.

09.03.21 – Building demolition complete in the northern part of the site, recovery of hardstanding for processing

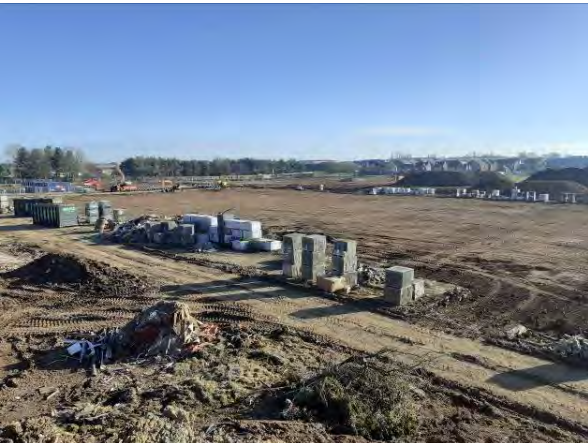
33.

09.03.21 – Eastern part of the site trimmed awaiting formation testing

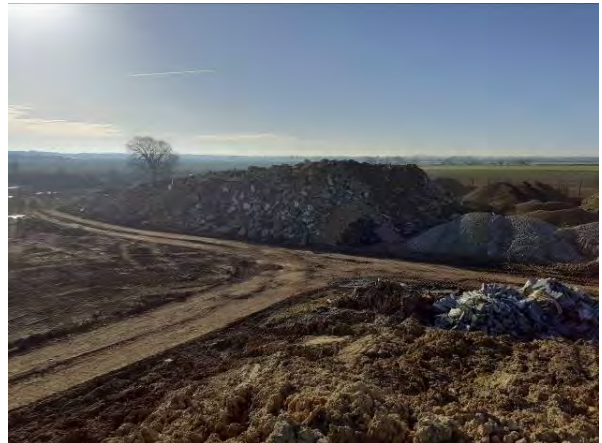
34.

09.03.21 – Stockpile of recovered hardstanding awaiting processing to generate aggregate

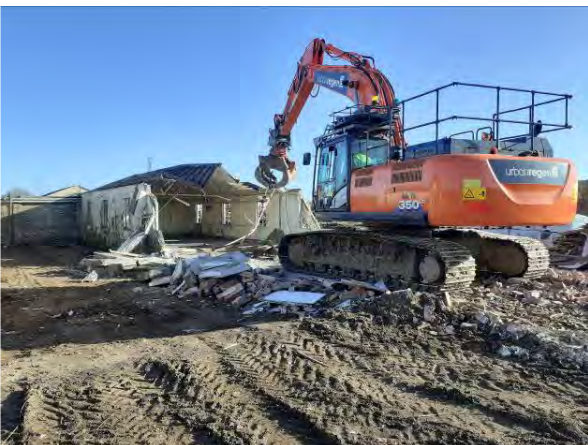
35.

09.03.21 – Building demolition

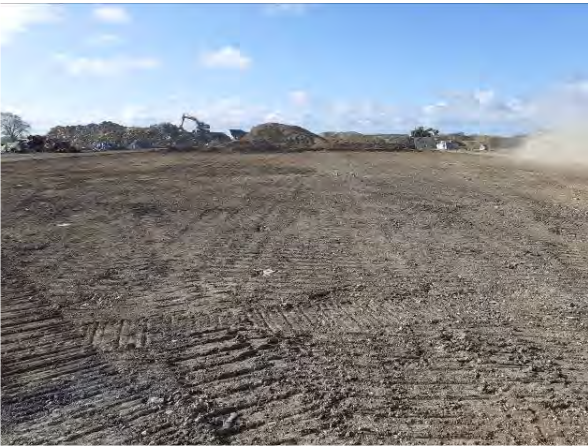
37.

06.04.21 – Western part of site demolition complete, hardstanding removed, and site regraded ahead of formation sampling

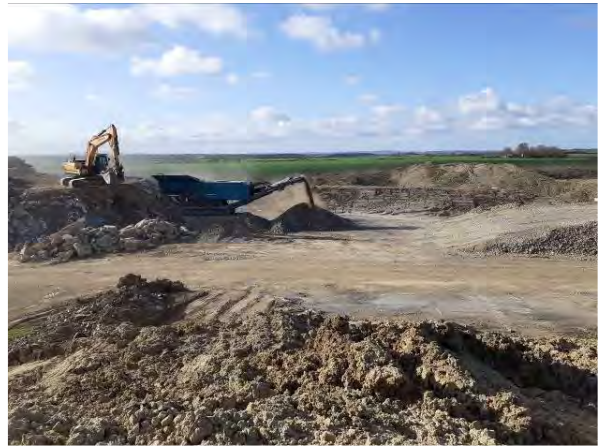
38.

06.04.21 – Crushing site-won hardstanding commencing

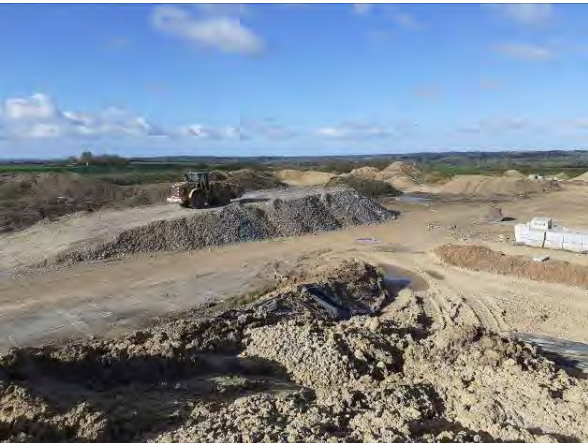
39.

06.04.21 – Formation of site-generated aggregate stockpile (Agg-SP1) in the south

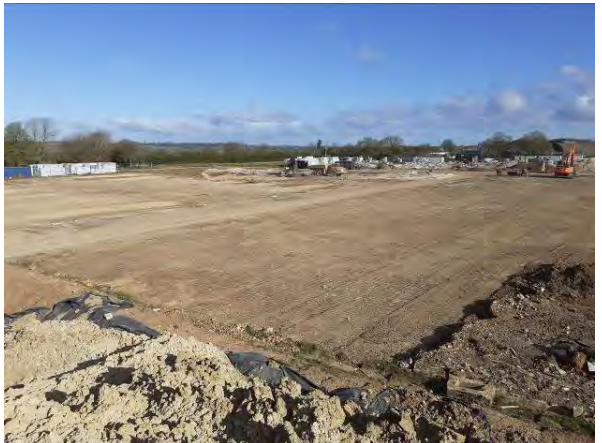
40.

06.04.21 – North-western view across the site following building demolition and regrade

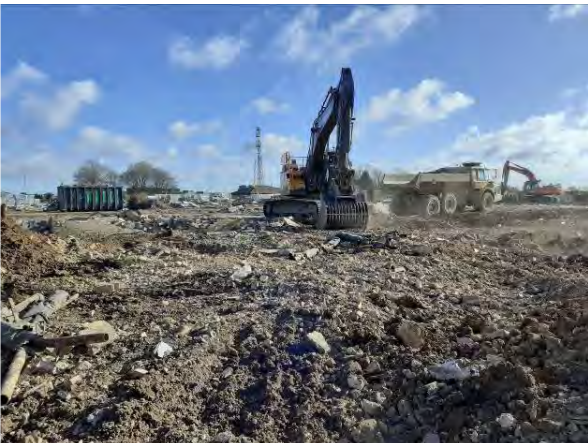
41.

06.04.21 – Recovery of demolition waste materials in the north

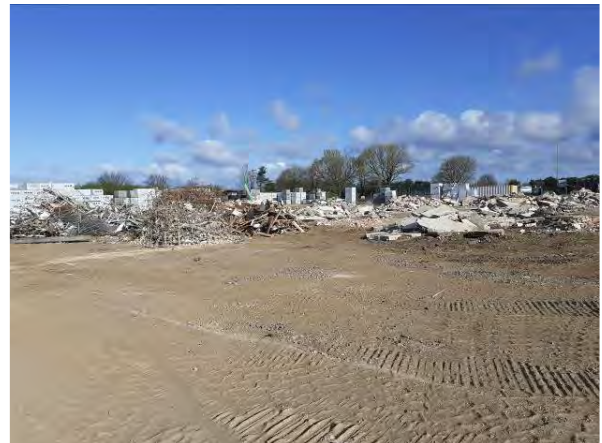
42.

06.04.21 – Temporary stockpiles of wastes (metal, wood and masonry) prior to recovery

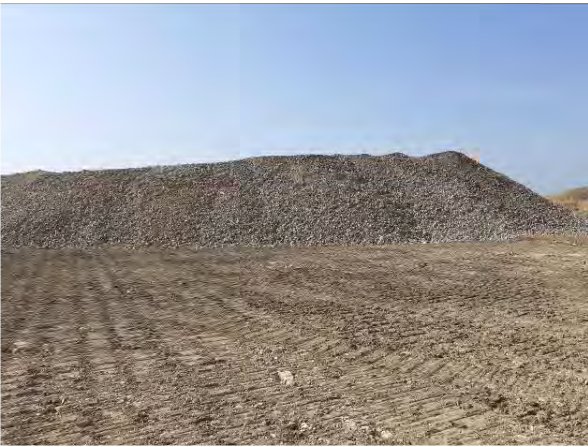
43.

20.04.21 – Stockpile of site-generated aggregate (Agg-SP2)

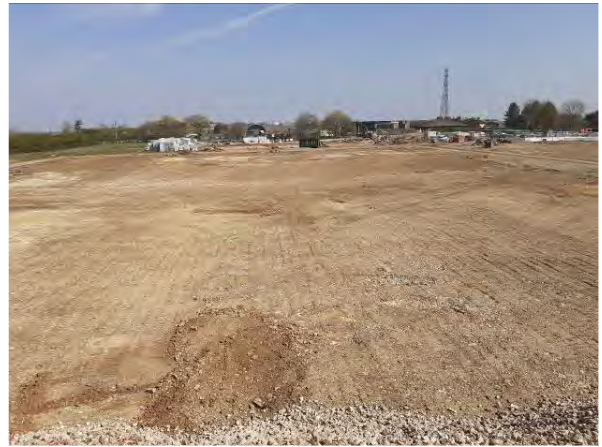
44.

20.04.21 – Northern view across site

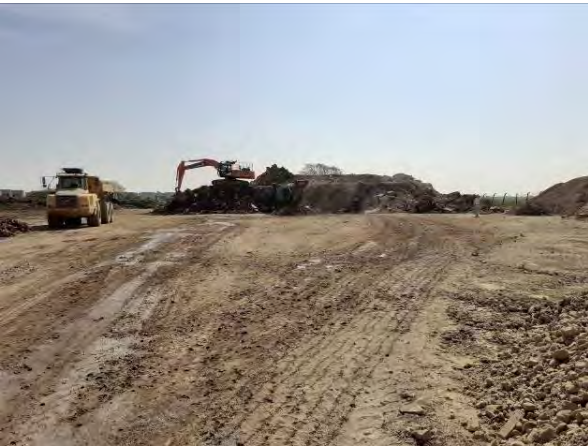
45.

20.04.21 – Aggregate processing on-going

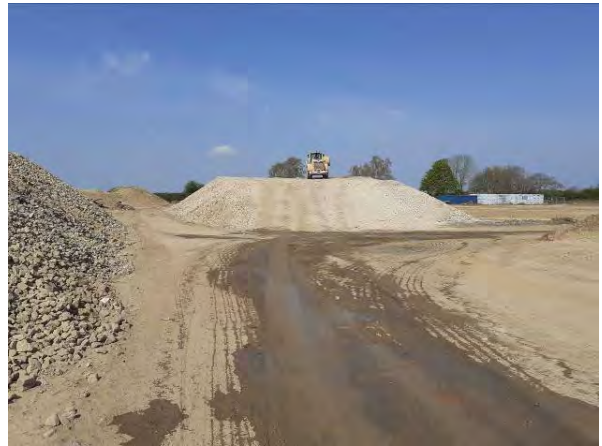
46.

20.04.21 – Dust suppression taking place during dry conditions

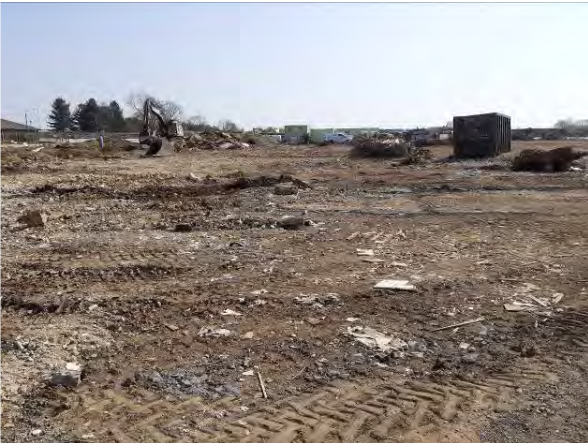
47.

20.04.21 – Eastern view across the north of the site following building demolition and hardstanding removal but prior to regrade

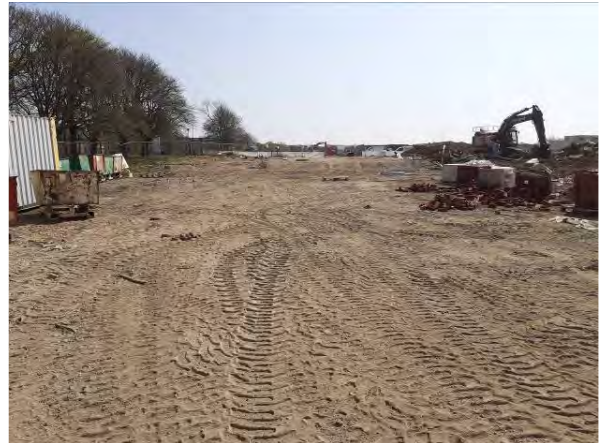
48.

20.04.21 – Eastern view across the north of the site

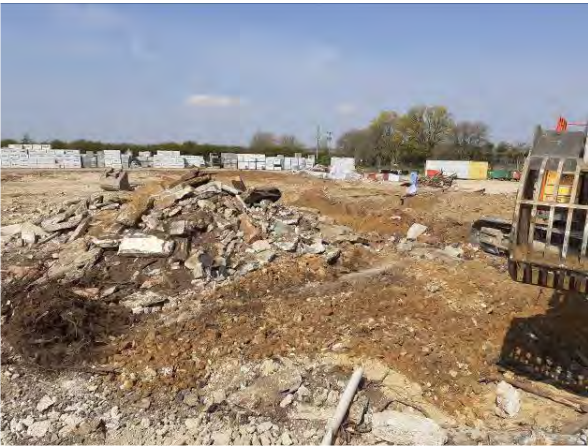
49.

20.04.21 – Handpicking of ACM fragments within localised area in the north (HS-ACM) by specialist sub-contractor

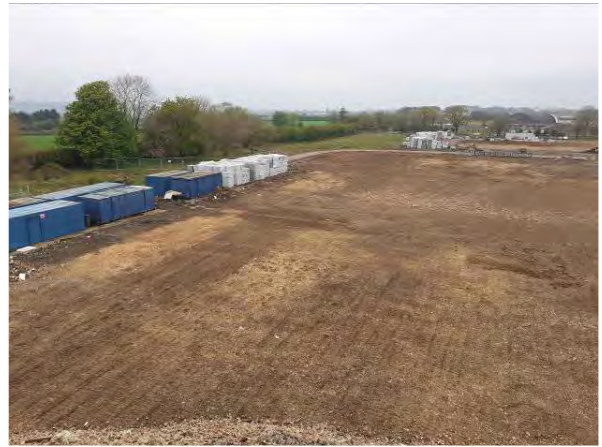
50.

28.04.21 – Northern view along the western end of the site

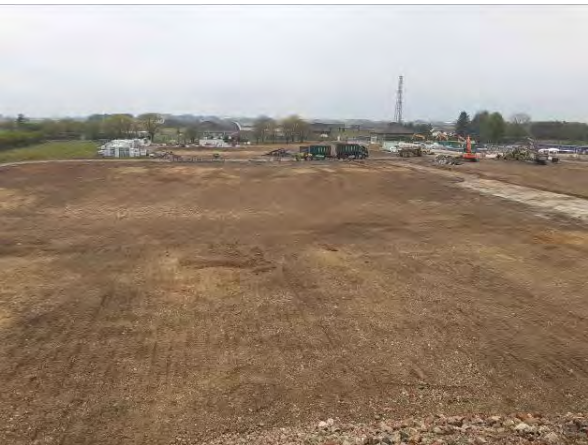
51.

28.04.21 - Northern view across centre of site

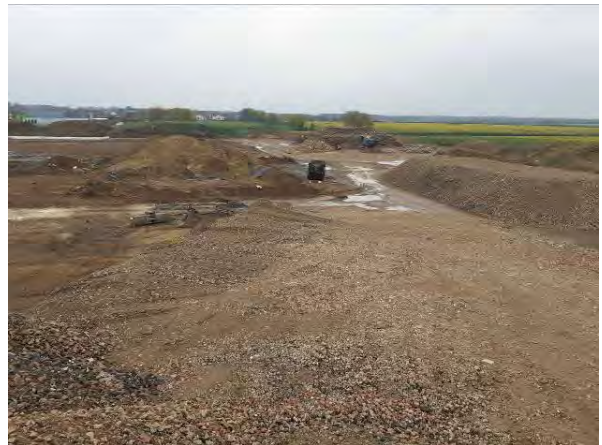
52.

28.04.21 – Eastern view of southern end of site with site-generated aggregate stockpiles present

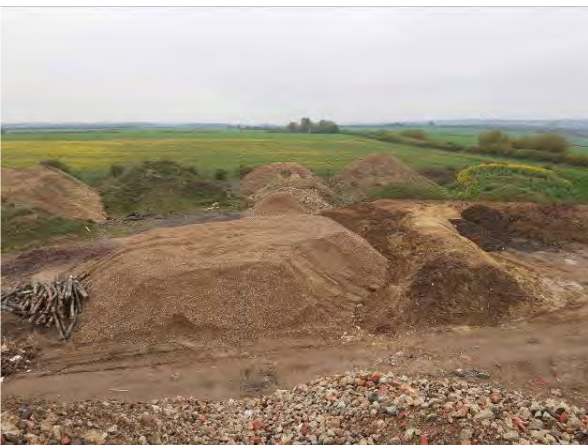
53.

28.04.21 – Stockpiles of arisings generated from wider Heyford development temporarily stored in the south

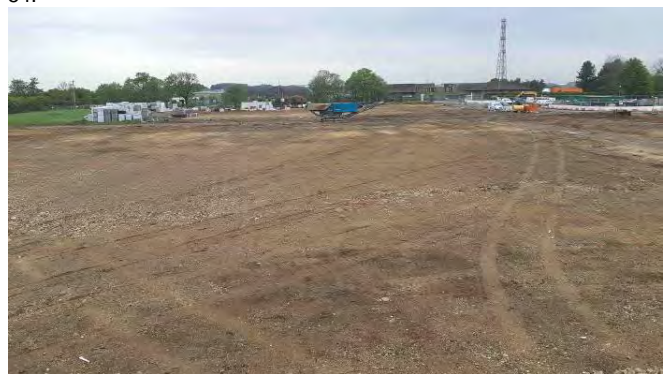
54.

13.05.21 – Northern view following completion of works

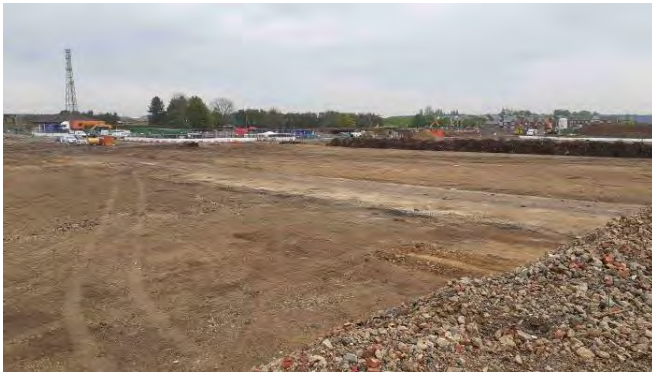
55.

13.05.21 – North-eastern view following completion of works

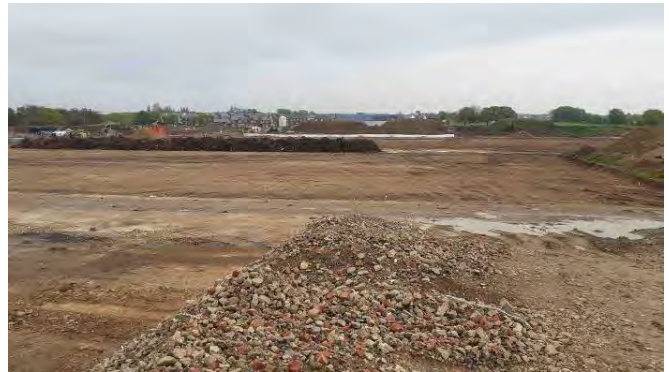
56.

13.05.21 – Eastern view

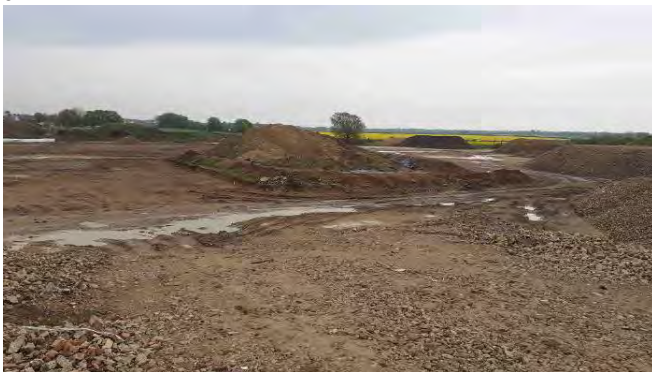
57.

13.05.21 -South-eastern view. Temporary stockpile of contaminated soils from Phase 9 baseball pitch remains within quarantine area

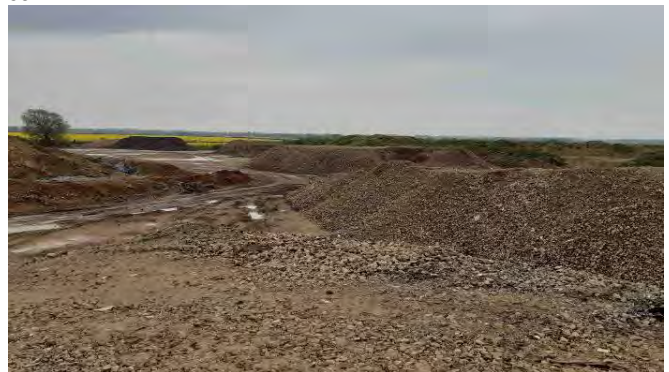
58.

13.05.21 – Stockpiles of site-generated aggregate present in the south

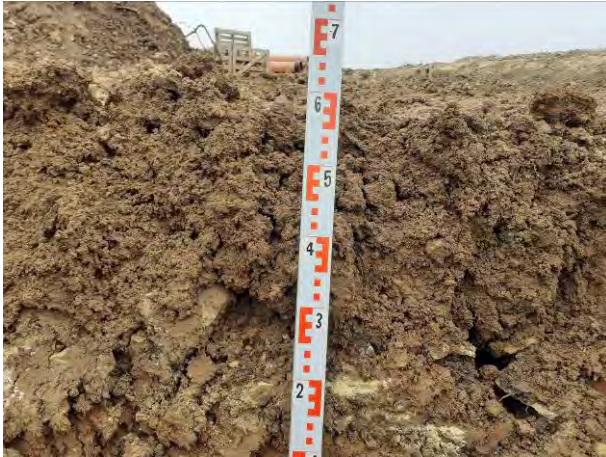
1.

02.03.21 – Formation Validation: S1

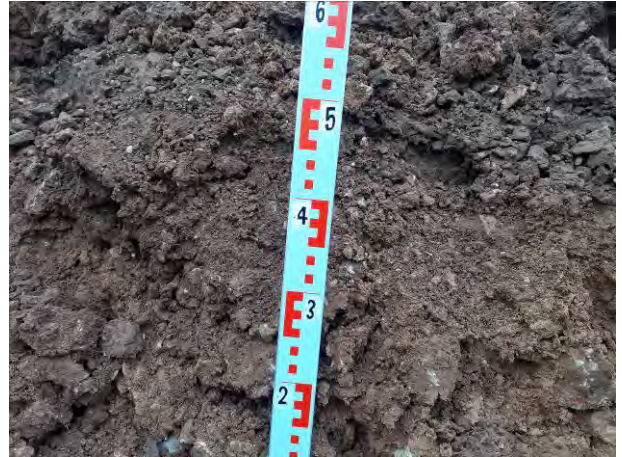
2.

02.03.21 – Formation Validation: S2

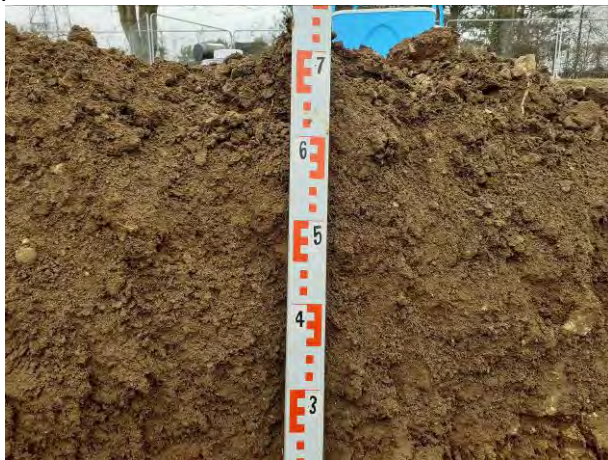
3.

02.03.21 – Formation Validation: S3

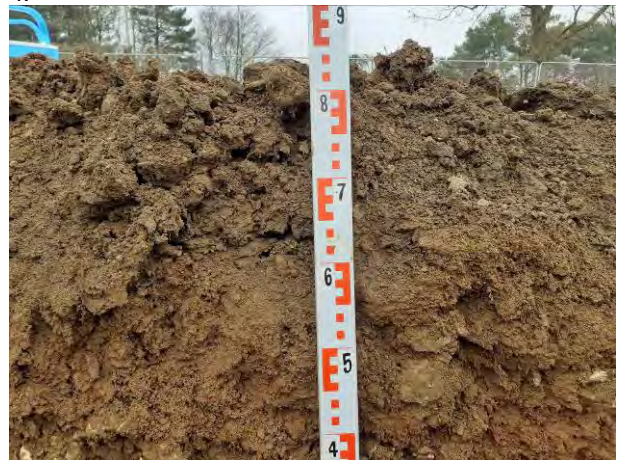
4.

02.03.21 – Formation Validation: S4

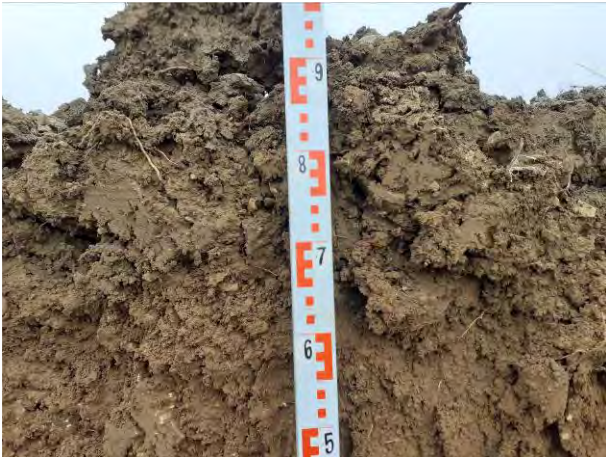
5.

02.03.21 – Formation Validation: S5

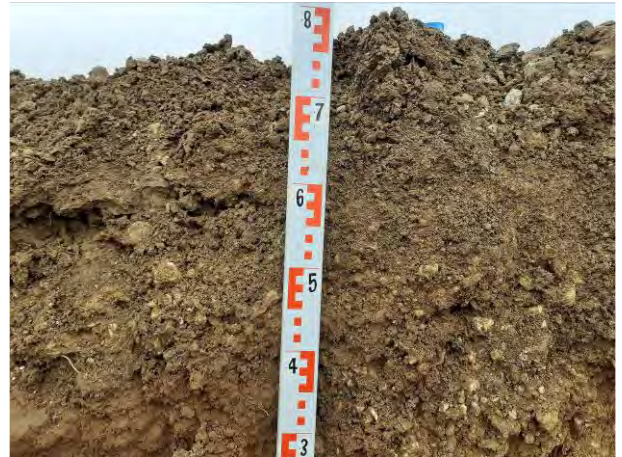
6.

02.03.21 – Formation Validation: S6

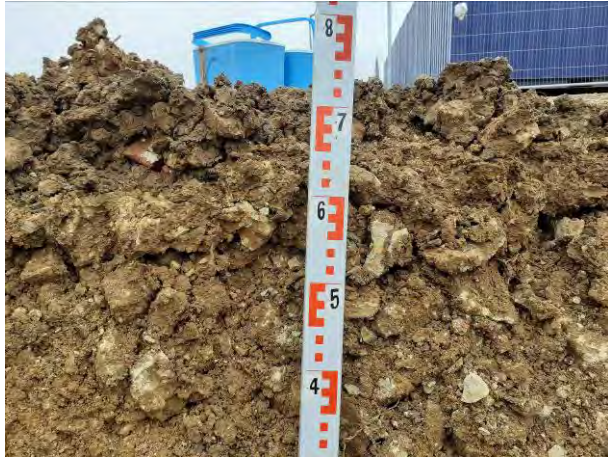
7.

02.03.21 – Formation Validation: S7

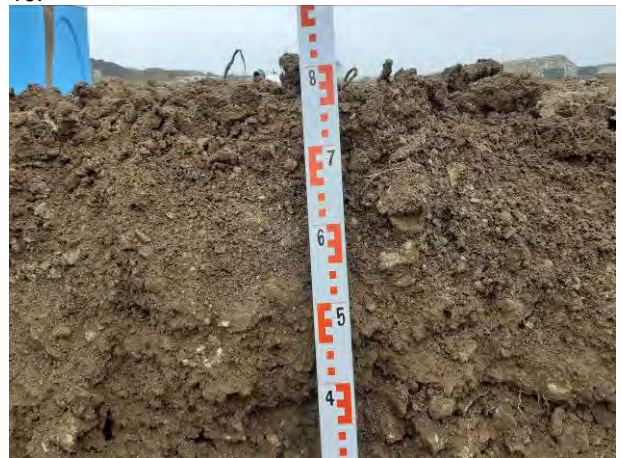
10.

02.03.21 – Formation Validation: S10

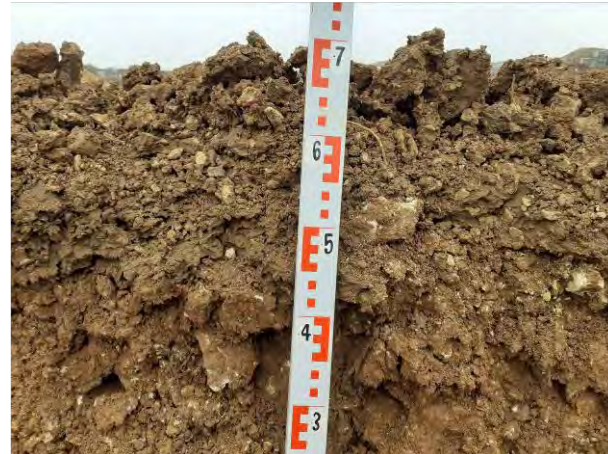
11.

02.03.21 – Formation Validation: S11

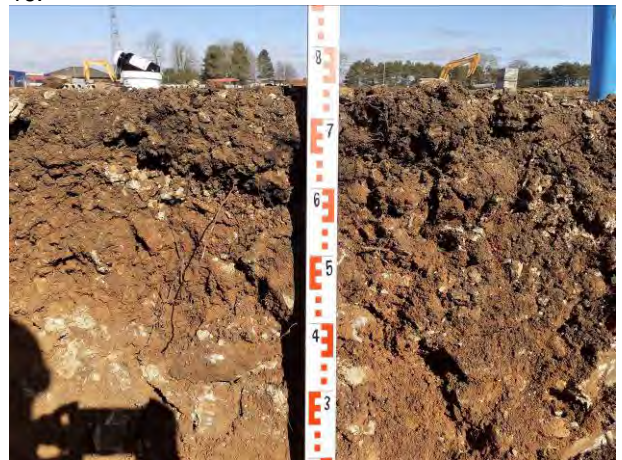
16.

09.03.21 – Formation Validation: S16

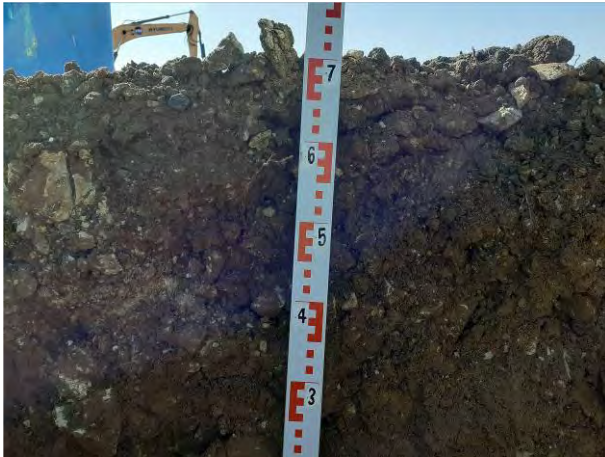
17.

09.03.21 – Formation Validation: S17

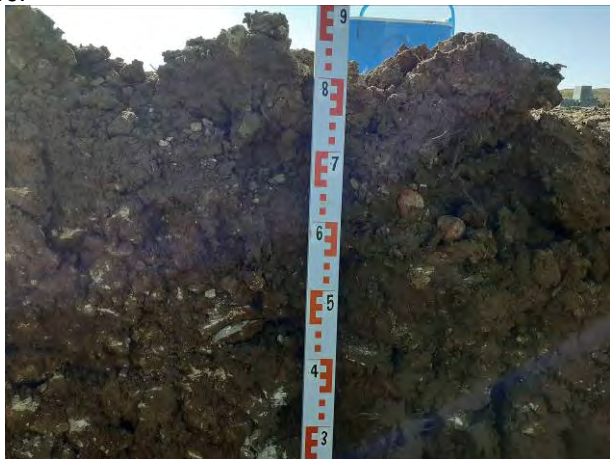
19.

09.03.21 – Formation Validation: S19

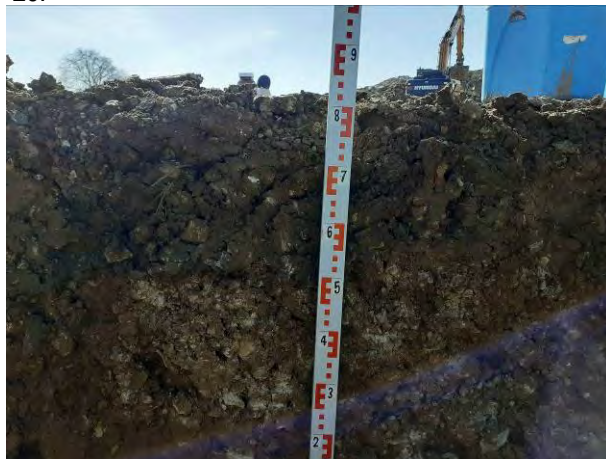
20.

09.03.21 – Formation Validation: S20

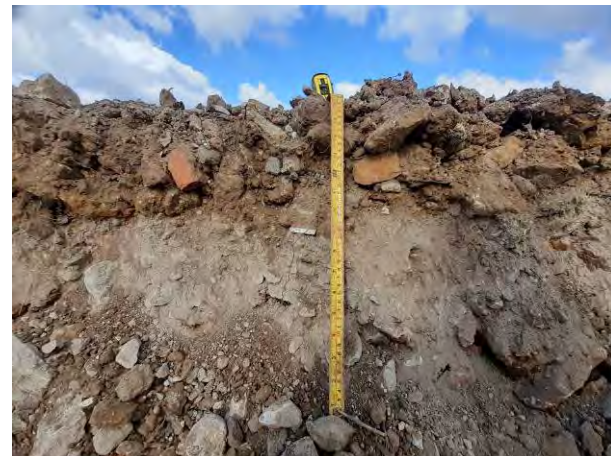
24.

06.04.21 – Formation Validation: S24
