Operational Inspection

Banbury Longford Park Development Phase 1

Inspection Ref: 1919439

Operational Inspection - 16-January-2023 - 10:04 Inspector Mark Perkins

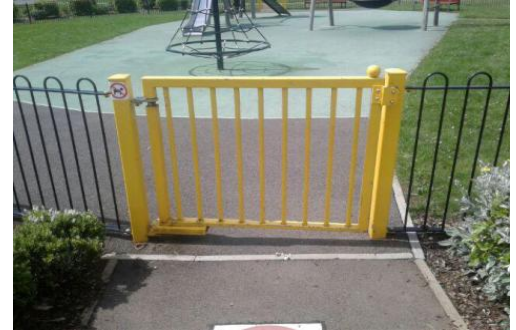
All the gates are closing too quickly (less than 4 seconds) - All Gates operating correctly

Gates noisy - Lubricate gates

Gate has no slam plate - Install slam plate

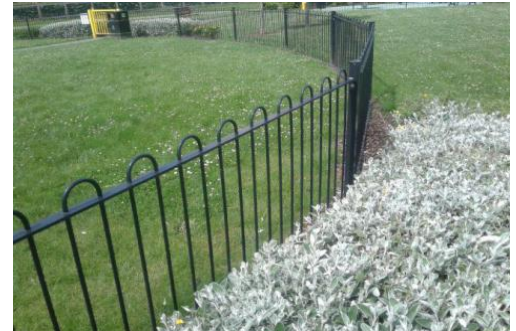
There is some damage to the fence sections - Monitor for any further deterioration and repair as required

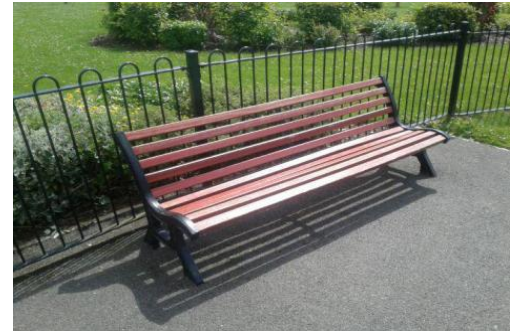
A number of fixing(s) have worked loose - Fixings secured

Caps missing - Caps replaced

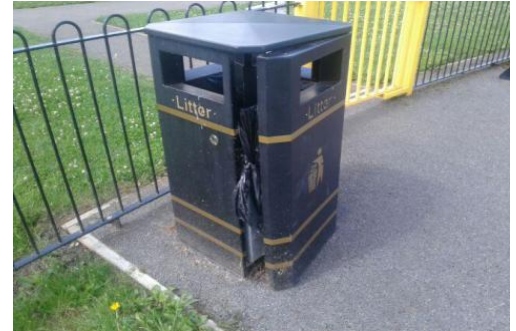
The litter bin is full - Empty and review the collection routine

The lid or door of the litter bin is not secured - Ensure the lid or door is kept locked

Bin - Bin emptied

Bin has graffiti - Remove graffiti

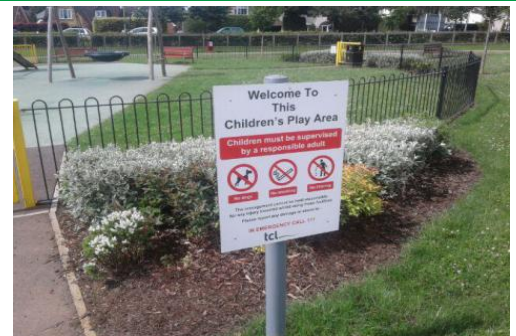
Cap missing - Replace cap

Sign loose - Tighten sign

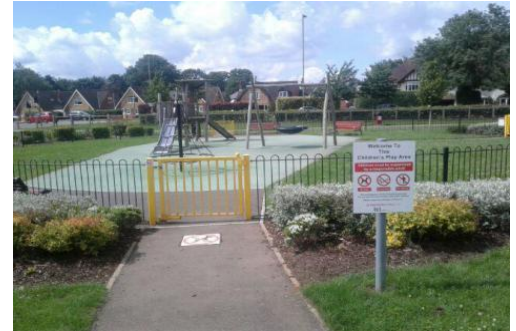
It is recommended that information signs with emergency contact details are installed at each entrance/exit point to the playground - Provide in accordance with the recommendations set out in BS EN 1176

Part of the no dog sign is missing creating a potential trip hazard. - Reinstate sign.

The signage is damaged or missing - Replace signage

There are post / end caps missing from the item - Replace missing post caps

Sign - Sign replaced

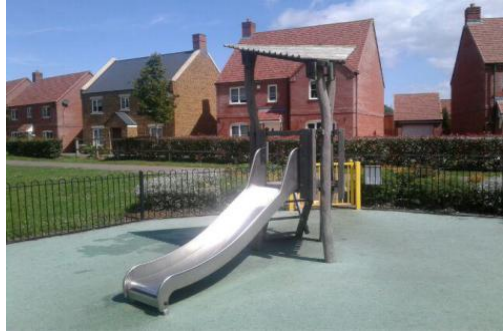
Finding 1	Finding 2
There are splits in the timber running through fixing point, - monitor to ensure this does not create instability in the structure	A number of fixing(s) have worked loose - Fixings tightened
Finding 3	Finding 4
Loose fixings - Tighten fixings on steps and handrail	Timber starting to show signs of rot - Replace timber

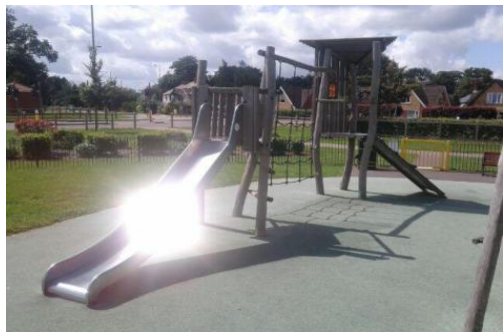
Finding 1	Finding 2
The timber has a number of splits (shakes) although these are not considered to be a problem at present - Monitor to ensure the splits do not cross through fixing points of the structure and cause any instability	Fungus was found on site (see photos) - Identify fungus type and remove if poisonous; if classified as non-harmful leave on site
Finding 3	Finding 4
There is some evidence of rot in the timber - Monitor for any further deterioration and replace as required	Timber slats rotted on ramp - Replace slats
Finding 5	Finding 6
Slats rotting - Slats replaced	Item has graffiti - Remove graffiti
Finding 7	
Slats installed have rough edges - Round off and smooth edges

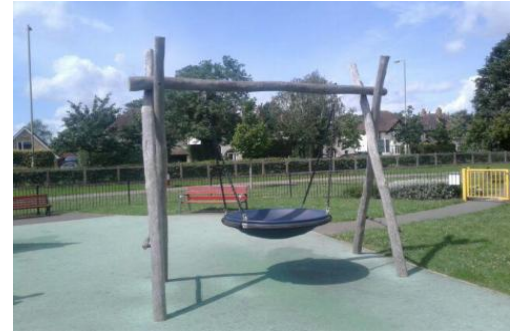
The timber has a number of splits (shakes) although these are not considered to be a problem at present - Monitor to ensure the splits do not cross through fixing points of the structure and cause any instability

Wet pour raising - Wet pour repaired

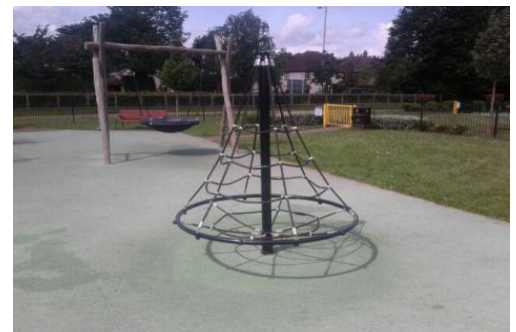
The ropes/nets are worn/damaged in places - Monitor for any further deterioration and repair or replace as required

Net fixings loose - Tighten fixings

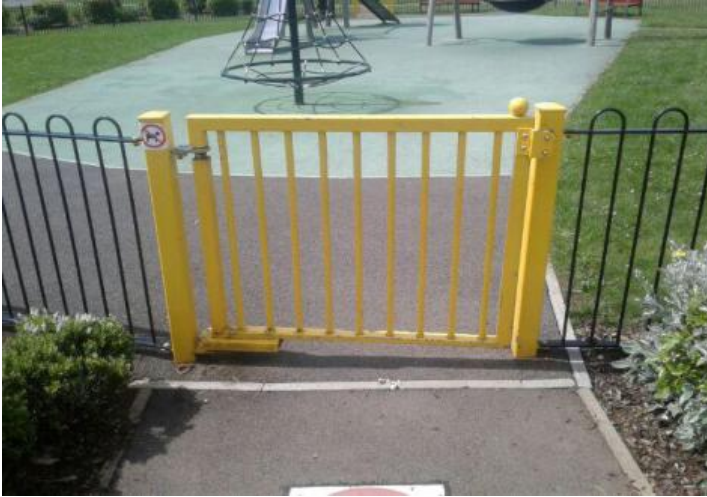
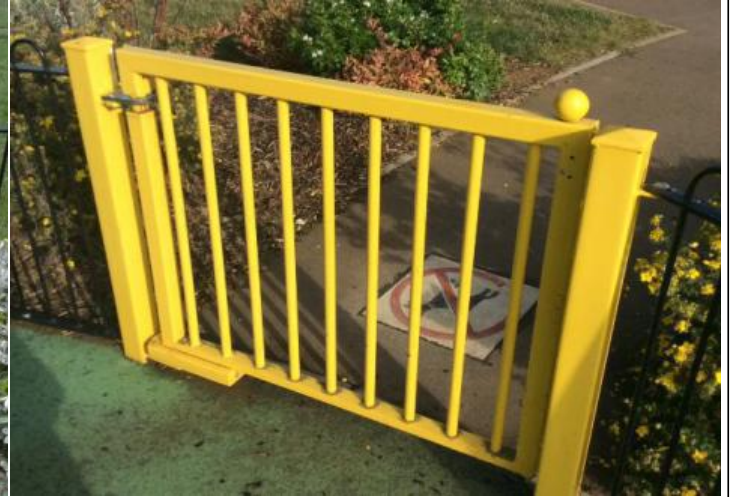
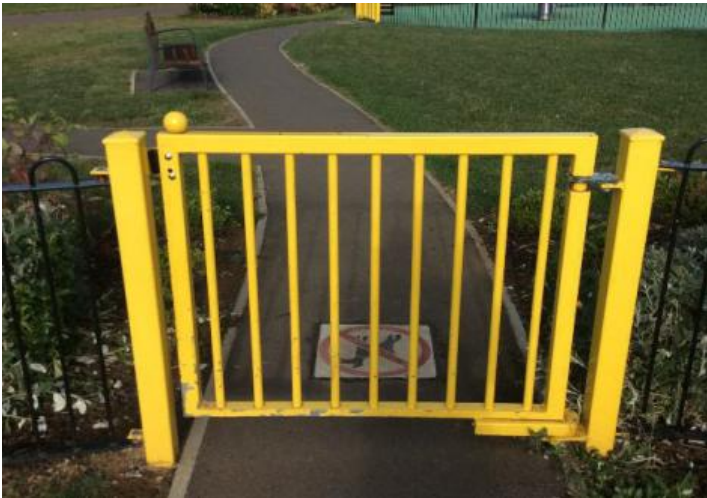
Finding: All the gates are closing too quickly (less than 4 seconds)

Action: All Gates operating correctly

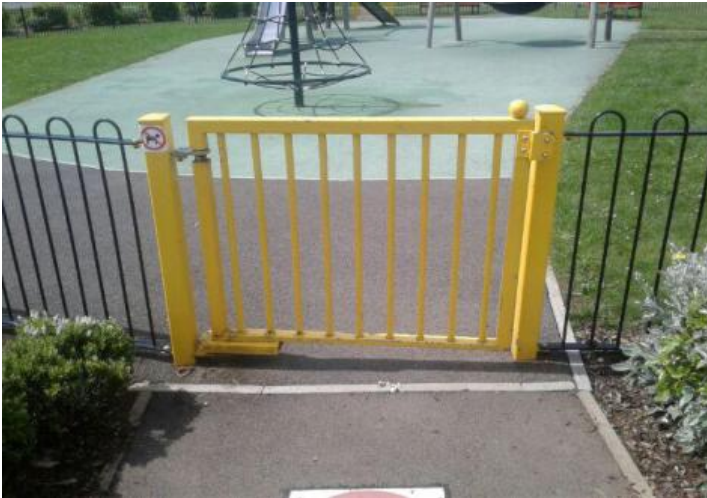
Finding: Gates noisy

Action: Lubricate gates

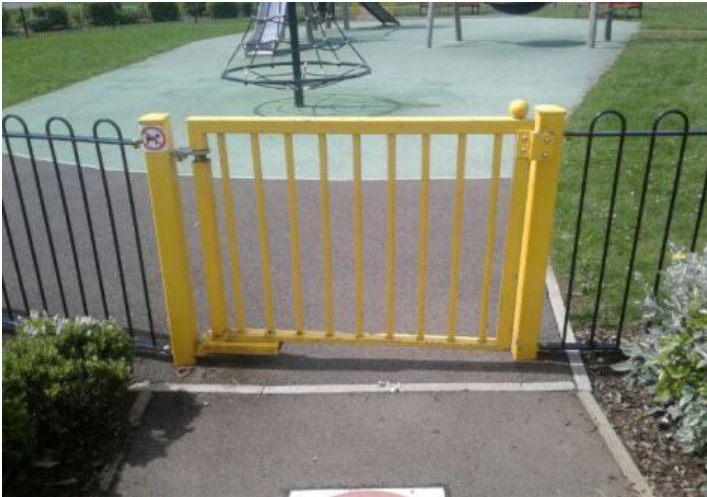
Finding: Gate has no slam plate

Action: Install slam plate

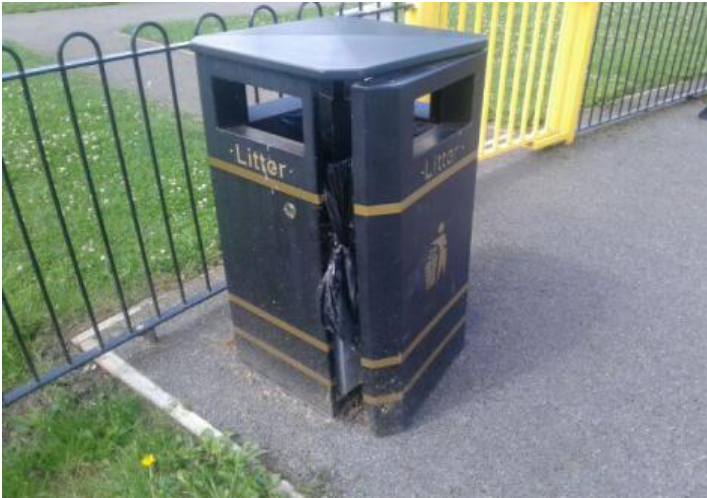
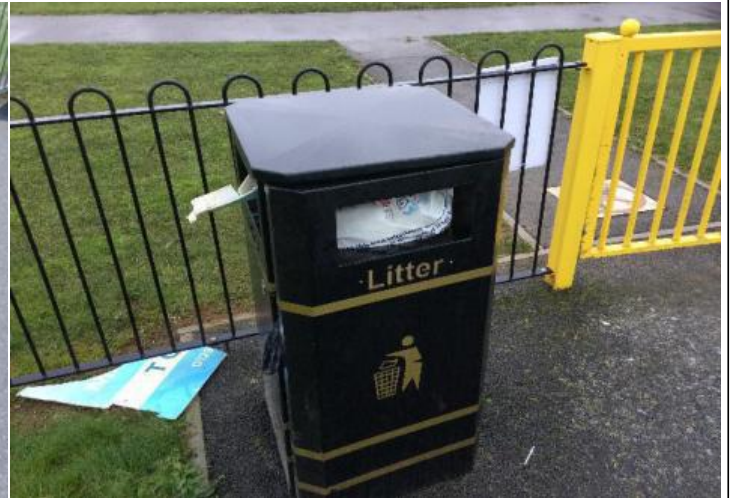
Finding: The litter bin is full

Action: Empty and review the collection routine

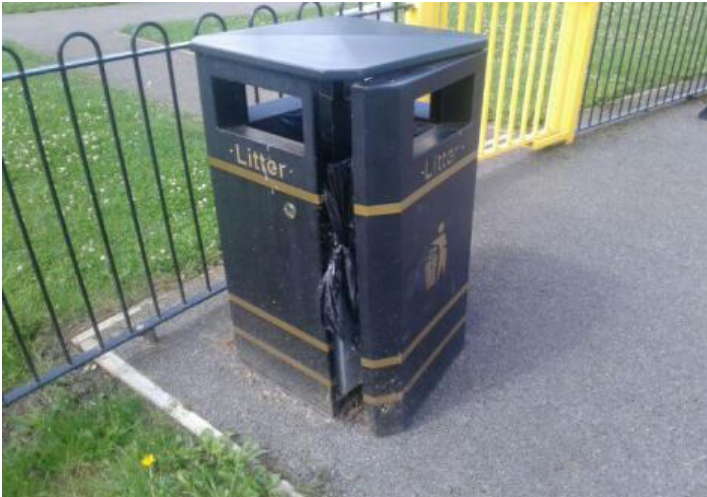
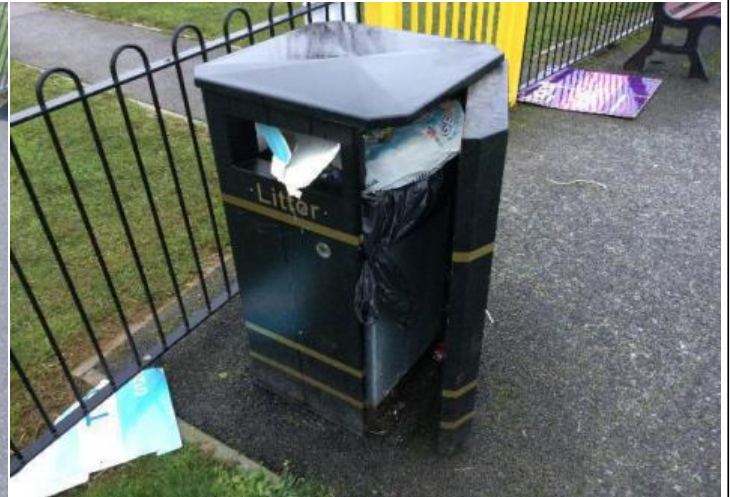
Finding: The lid or door of the litter bin is not secured

Action: Ensure the lid or door is kept locked

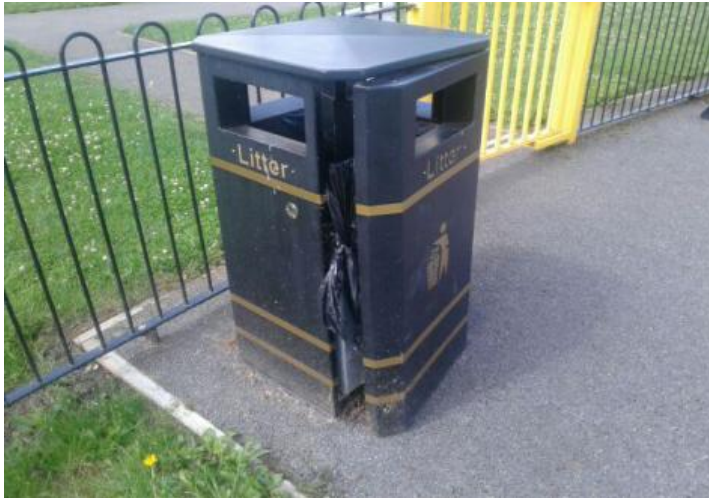
Finding: Bin

Action: Bin emptied

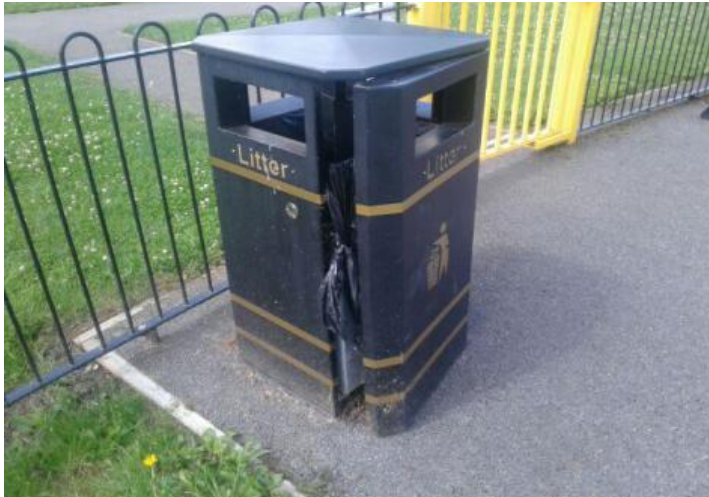
Finding: Bin has graffiti

Action: Remove graffiti

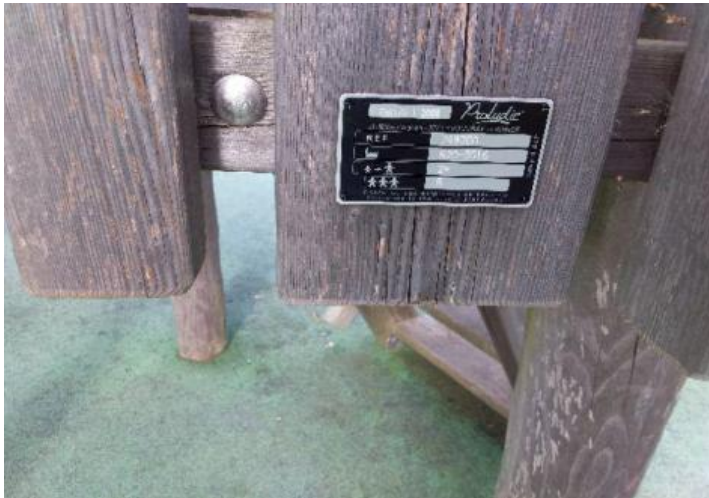
Finding: There are splits in the timber running through fixing point,
Action: monitor to ensure this does not create instability in the structure

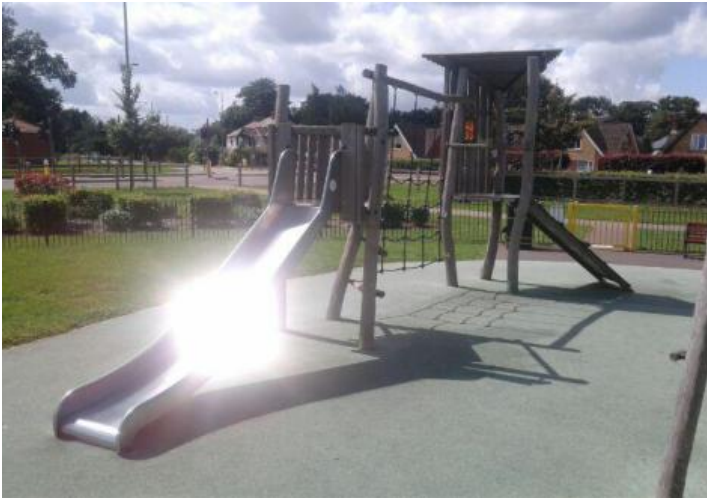
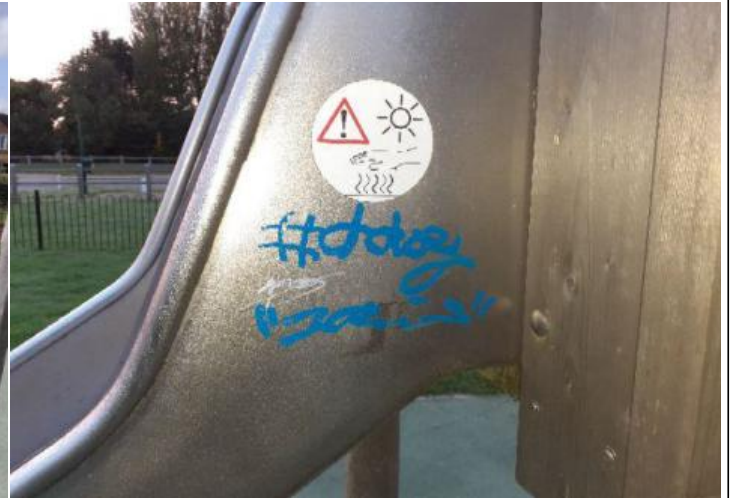
Finding: Item has graffiti

Action: Remove graffiti

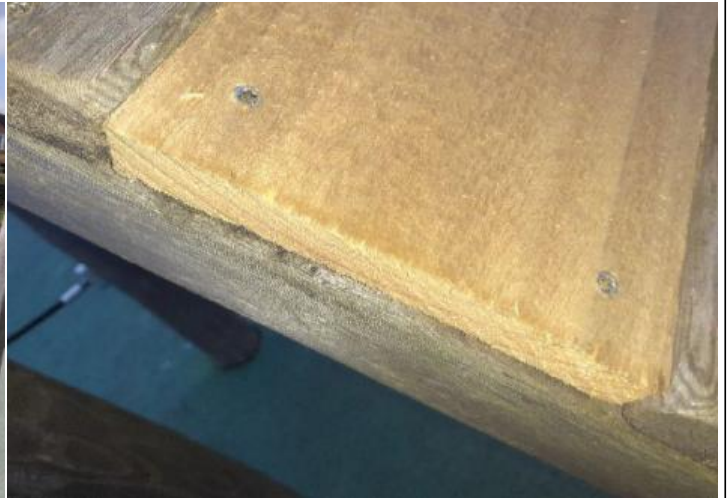
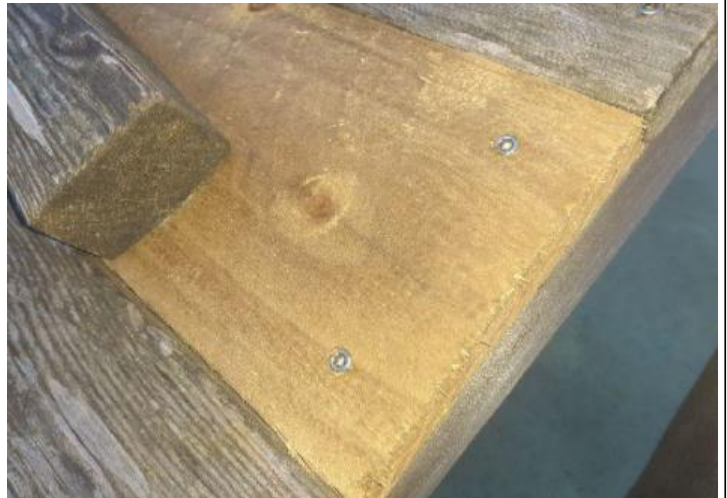
Finding: Slats installed have rough edges

Action: Round off and smooth edges
