Additional Sites at Sites D&E, DSDC Bicester

Land Quality Assessment

Phase One: Desk Study
DE Project No.: 13014

Final LQA Report

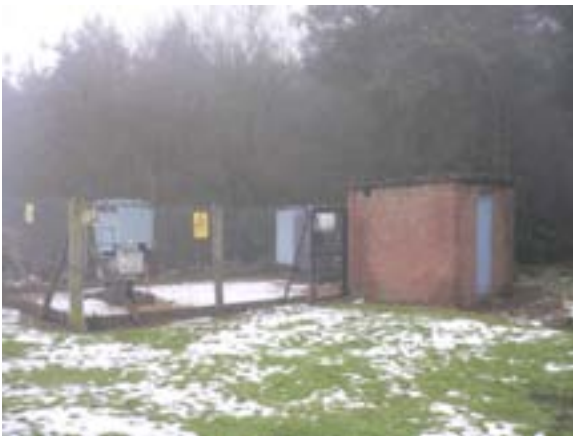
Plate 3: Transformer 1

There are two distribution substations (DSS) within Area 1; one adjacent to the Garrison Theatre (see Plate 3 in Annex A) and one adjacent to the roadway loop in the far east of the site (see Plate 7 in Annex A). They both appear to be in good order with no obvious signs of leaks. However, the ground within the DSS compounds has recently been covered with gravel, making it difficult to check for signs of previous leaks. During the site walkover at the adjacent D&E Sites, contractors were noted on site replacing some of the transformers and laying down gravel. They do not recollect there being any obvious signs of major leakage at any of the DSS. According to the contractors, transformers within the DSS compounds are replaced as soon as there is the slightest indication of any leakage onto their respective concrete plinths.

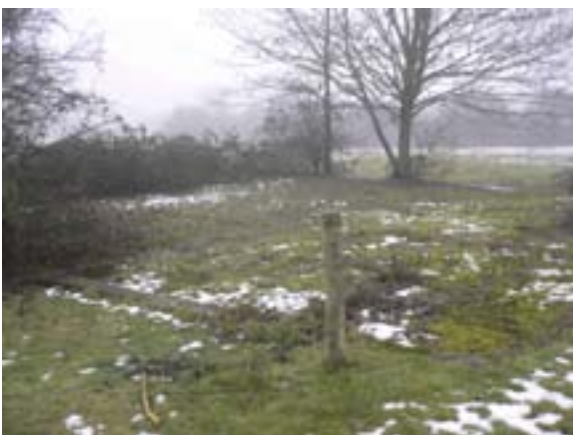
Plate 5: Concrete Plinth 1

- Field forming far western part of Area 1: A small brick building appears to have been demolished in-situ at a location immediately north of the circular road separating Areas 1 and 2 (see Plate 10 in Annex A). A further pile of building rubble was also noted further to the west within this field;
- South-east of Area 1, to immediate south-east of circular road: There is a 10x10 m concrete plinth with a brick surround (representing a probable former building) and a overgrown 10x20 m concrete plinth, representing a probable area of hardstanding (see Plates 5 and 6 in Annex A).

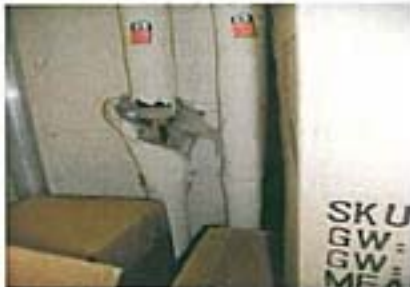
Photo 1 – 1.24 Store Room – Sample 1: Paper lining to pipework – Chrysotile

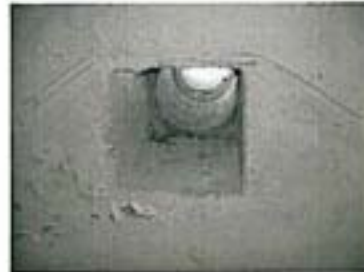
Photo 2 – 1.23 Store Room – Strongly Presumed asbestos to cement sleeve through ceiling to roof

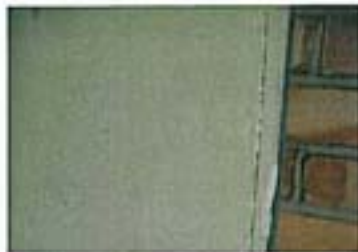
Photo 3 – 1.23 Store Room – Sample 2: Insulation panel to door x2 – Chrysotile

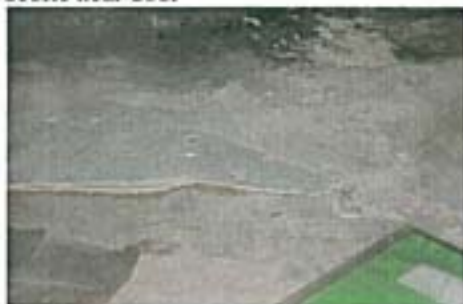
Photo 7 – G30 under stage – Strongly Presumed Asbestos insulating board panel and debris near door

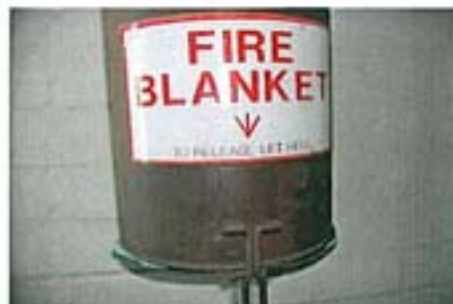
Photo 8 – 1.08 Lobby – Strongly Presumed asbestos blanket (fire)

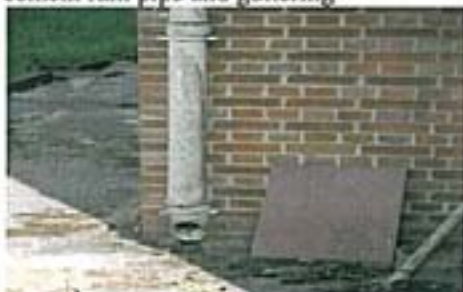
Photo 9 – External EX01 – Strongly Presumed cement rain pipe and guttering

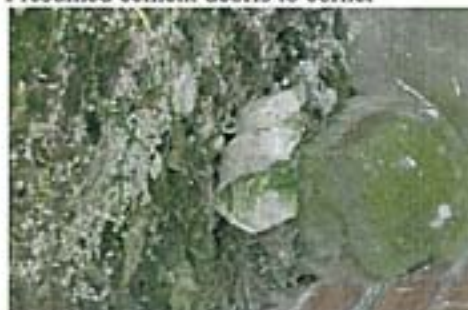
Photo 10 – External EX01 – Strongly Presumed cement debris to corner

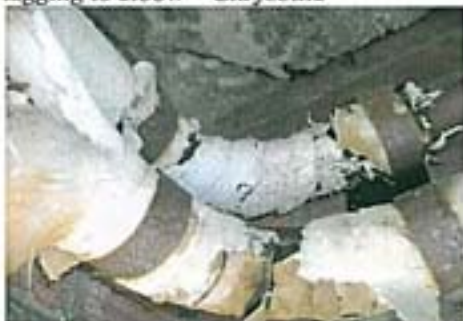
Photo 11 – EX02 Porch – Sample 7: Pipe lagging to elbow – Chrysotile

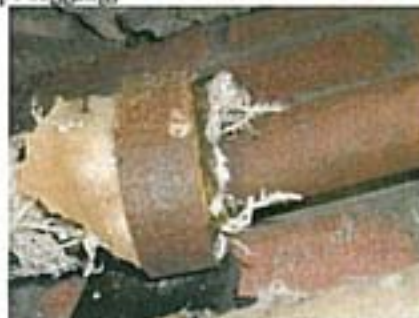
Photo 12 – EX02 Porch – Strongly Presumed asbestos to rope (wrapped around pipe lagging)

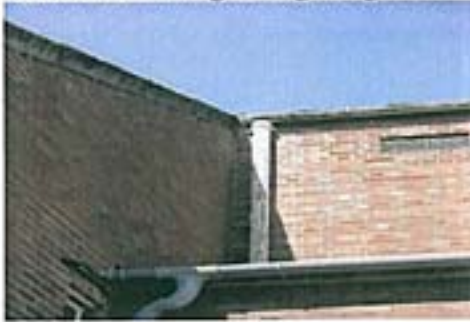
Photo 13 – EX01 – Strongly Presumed asbestos to cement guttering at high level

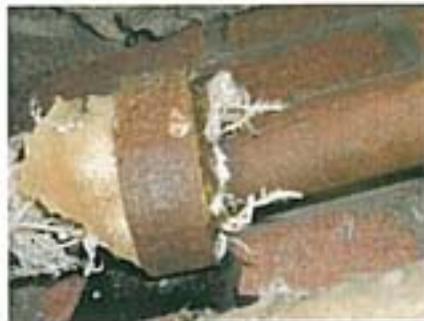
Photo 14 - EX02 Porch – As Sample 1: Paper lining to pipe - Chrysotile

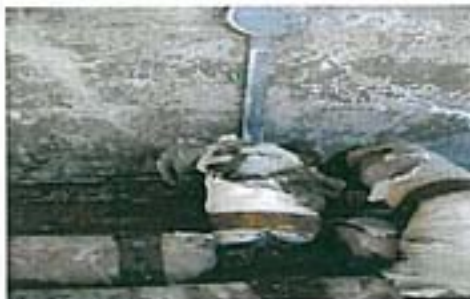
Photo 15 – EX03 Porch – As Sample 7: Pipe lagging to elbow – Chrysotile

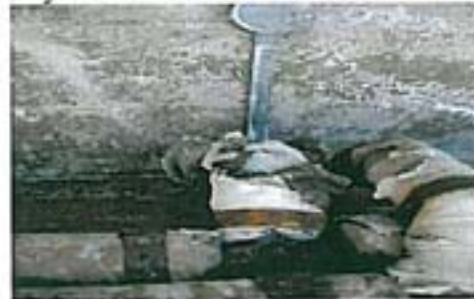
Photo 16 – EX03 Porch – As Sample 8: Rope (wrapped around pipe lagging) – Chrysotile

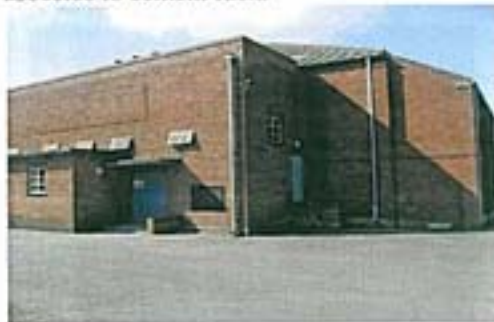
Photo 17 – EX01 – Strongly Presumed asbestos to cement facia

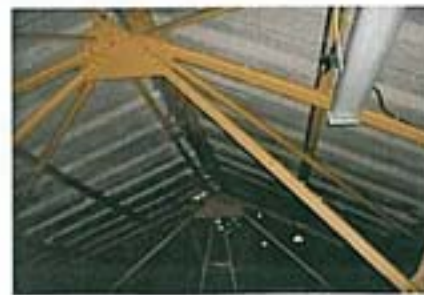
Photo 18 – 2.01 Roof Void – Sample 9: Cement sheeting to roof – Chrysotile

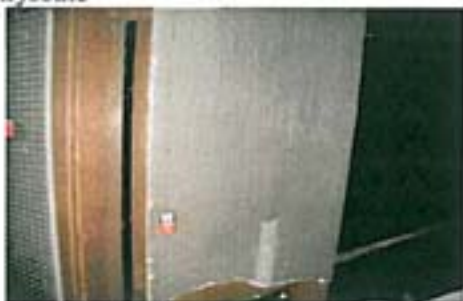
Photo 19 – 2.01 Roof Void – Sample 10:
Insulation panel and debris to door –
Chrysotile

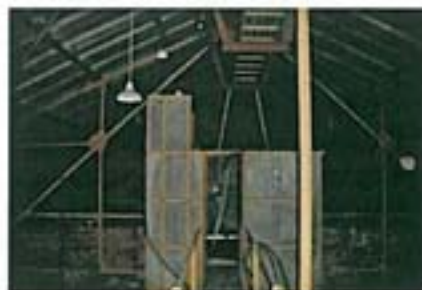
Photo 20 – 2.01 Roof Void – As Sample
10: Durasteel panels – Chrysotile

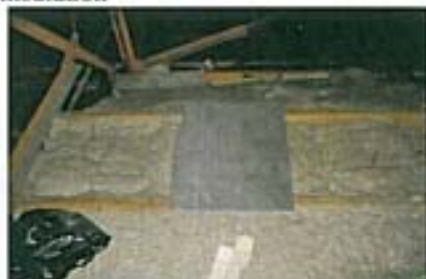
Photo 21 – 2.01 Roof Void – Strongly
Presumed asbestos to Durasteel panel on top of
2m insulation

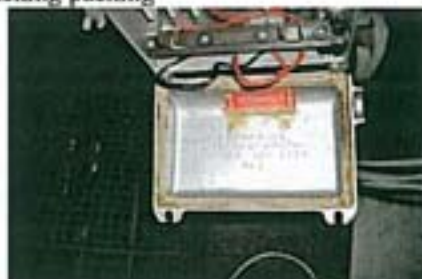
Photo 22 – 2.01 Roof Void – Sample 11:
Rope (in switch box x4) also used as
backing packing

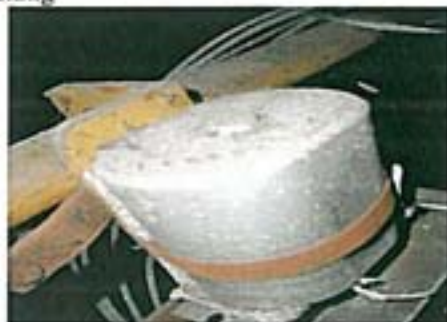
Photo 23 – 2.01 Roof Void – Sample 11: Rope
(in switch box x4) also used as backing
packing

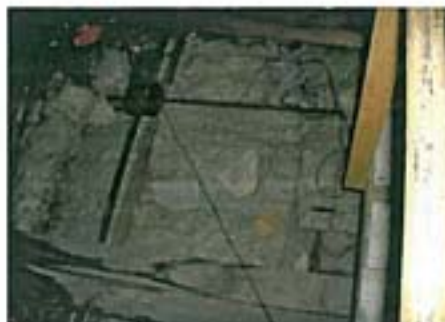
Photo 24 – 2.01 Roof Void – As Sample 9:
Cement debris – Chrysotile

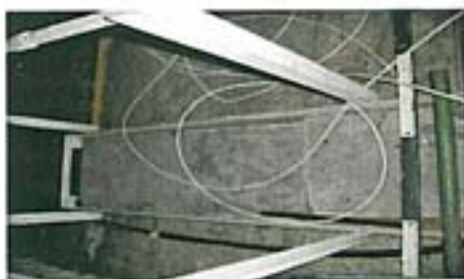
Photo 25 – 2.01 Roof Void – As Sample 9:
Cement panel below walkway – Chrysotile

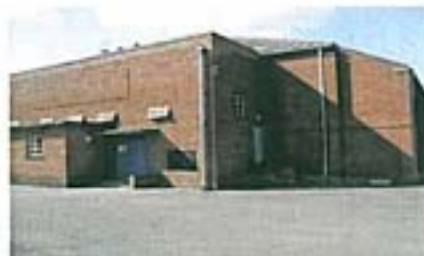
Photo 26 – EX01 External – Strongly
Presumed asbestos to cement cowls x5 on
roof top

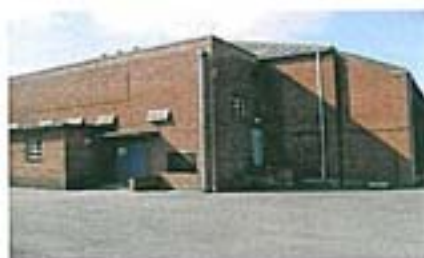
Photo 27 – EX01 External – Strongly
Presumed cement facia to roof
